Property Inspection Sample Report

Property Address
000 Someplace Drive
Your Town, CA

Inspector
Michael Fogli, RREI, CREI
CA Contractor License 319523

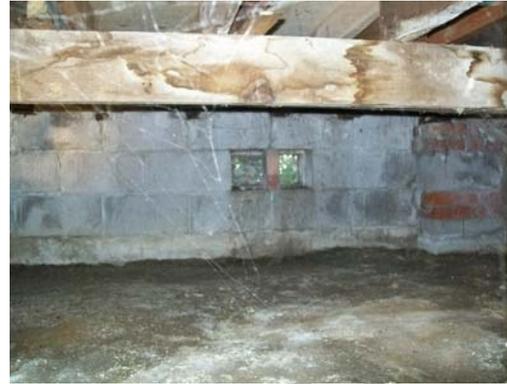
The brick entry is in serviceable condition. It is noted that the original wood supporting structure below the brick is still in place. Water stains and sagging was noted on the wood supports.

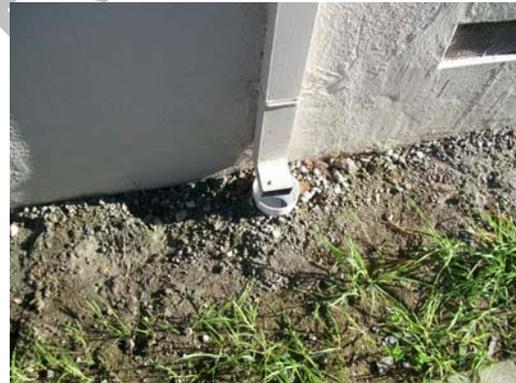
The overall drainage of the property appears to be in serviceable condition. Not all the downspouts are connected to an underground drainage system. Some are not properly funneled into the drains. The condition or existence of drainage systems around the property are not tested as a part of this report.

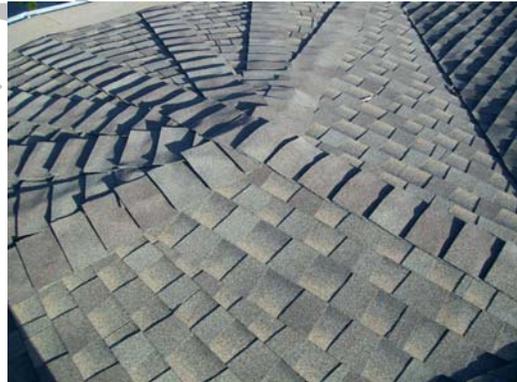
The fiberglass composition shingle roof appears to be in serviceable condition. A fiberglass composition shingle roof, if properly maintained, should have an expected overall lifespan of 15 to 20 years. The age of the roof was not determined.

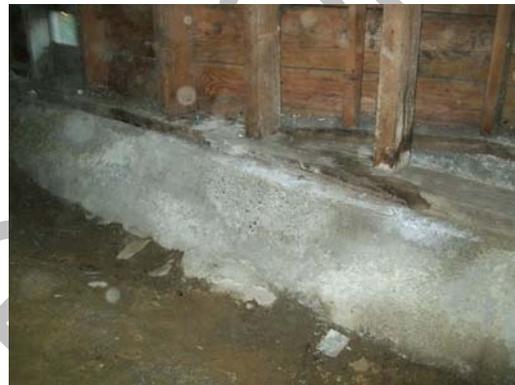
The perimeter foundation of the original home is a concrete battered (or angled) foundation. The depth or types of the footings is not known, nor a part of this report.

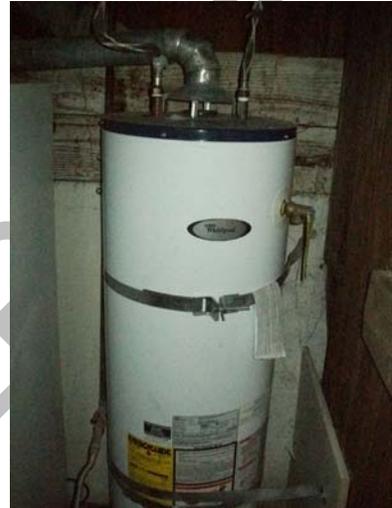
The natural gas hot water heater is located in the garage. The pressure relief valve is not plumbed. The flue is improperly installed. The slope of the flue is improper. The flue should have a minimum slope of $\frac{1}{4}$ " per foot to discharge. This flue is sloped downward. The hot water heater is seismically strapped. Water heaters generally have a 10-15 year life. The water heater is a 40 gallon unit that is 12 years old.

There is a masonry flue for the water heater and the furnace. While this was common building practice at the time when the home was built, it is presently not recommended, due to the possible cracking of the bricks and mortar, leading to carbon monoxide poisoning in the habitable rooms of the home. It is recommended that masonry flues be replaced with a UBC approved metal vent pipe.

1. Repair the flue as noted. A shorter water heater (or tankless water heater) should be used to provide the proper slope to discharge. Additionally, the metal flue should be used to duct both the water heater and furnace through the roof.
2. Plumb the pressure relief valve discharge pipe to within 6" of the concrete slab, or to the exterior of the building.

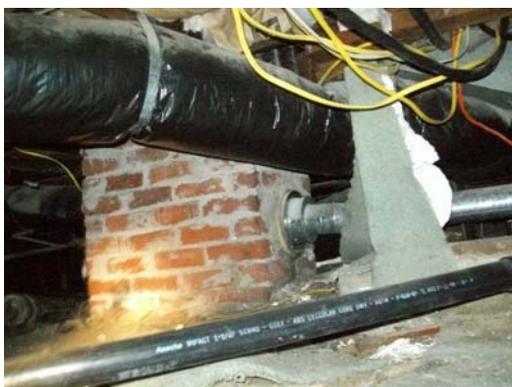
There is a masonry flue for the water heater and the furnace. While this was common building practice at the time when the home was built, it is presently not recommended, due to the possible cracking of the bricks and mortar, leading to carbon monoxide poisoning in the habitable rooms of the home. It is recommended that masonry flues be replaced with a UBC approved metal vent pipe.

It is noted that there is a broken duct in the sub area that hot air is escaping.

1. Encapsulate or remove the torn insulation on the heat duct pipes.
2. Repair the broken duct.

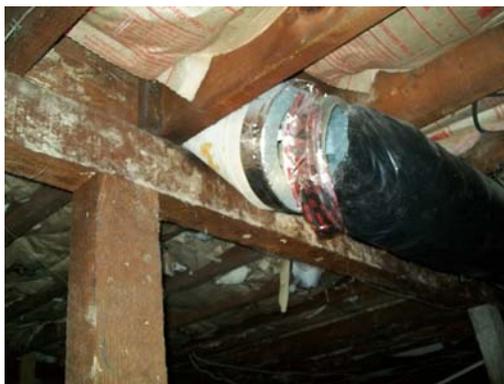
There may be asbestos on the heat duct boots. For further information about asbestos, contact a hazardous waste specialist. Asbestos in the torn or deteriorated condition is considered harmful. For further information about asbestos, contact a hazardous waste specialist.

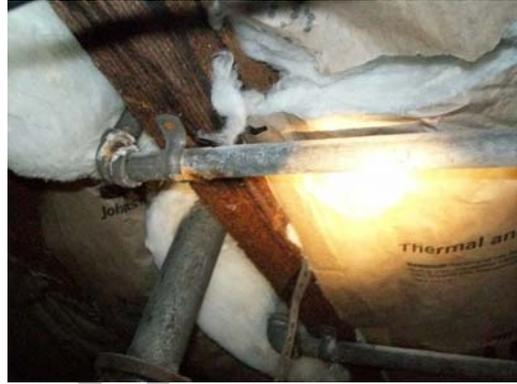
Galvanized steel water lines have a limited lifespan. The galvanized water lines under the original bathroom are in corroded condition. There is substantial rust on the joints of the pipes.

The water pressure is 90 psi (pounds per square inch). It is recommended a water regulator be installed below the main shut off to reduce the water pressure to the home to no more than 75 psi. Adequate water pressure should measure between 50 psi and 75 psi.

1. Removal of the galvanized water pipe is recommended.

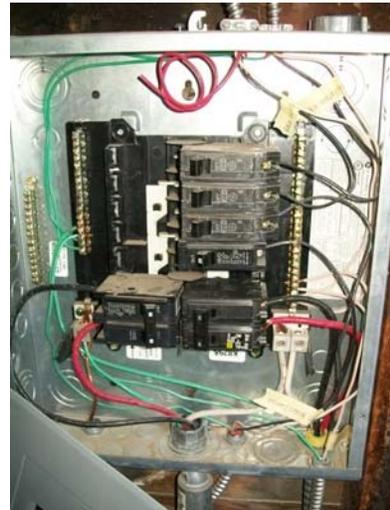
There are two circuit breaker sub panels: located in the garage and back hall. It is noted that the sub panels were not labeled. It is recommended that the panels be labeled to make a determination of where the circuits are connected. However, whenever repairing or working on the wiring, it is recommended that the main circuit breaker be shut off as an additional precaution against shock.

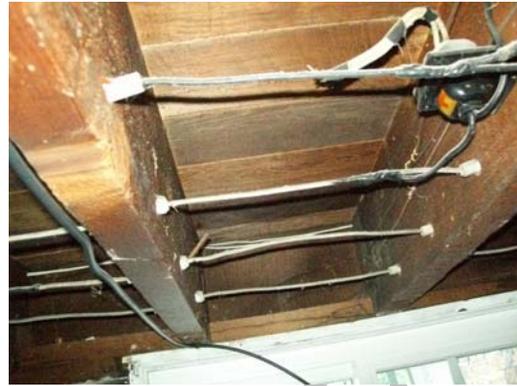
There is porcelain knob and porcelain tube wiring in the older section of the home. This is an ungrounded two wire, wiring system. This is considered an antiquated type of wiring that should be replaced with current NEC approved wiring. Have a licensed electrician inspect the wiring and make recommendations concerning replacement or repair.
