Property Inspection Sample Report

Property Address
000 Someplace Drive
Your Town, CA

Inspector
Michael Fogli, RREI, CREI
CA Contractor License 319523

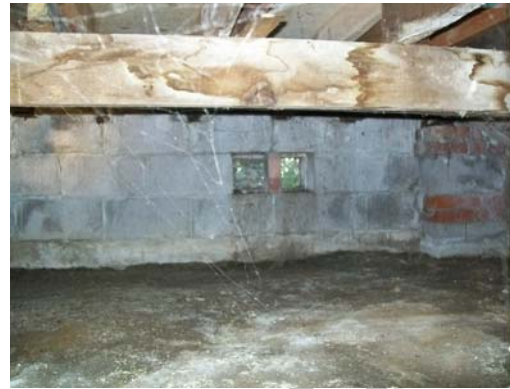
The brick entry is in serviceable condition. It is noted that the original wood supporting structure below the brick is still in place. Water stains and sagging was noted on the wood supports.

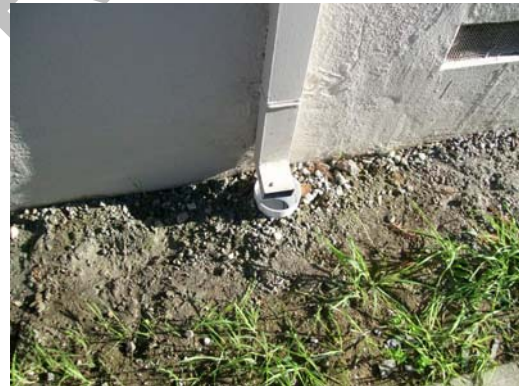
The overall drainage of the property appears to be in serviceable condition. Not all the downspouts are connected to an underground drainage system. Some are not properly funneled into the drains. The condition or existence of drainage systems around the property are not tested as a part of this report.

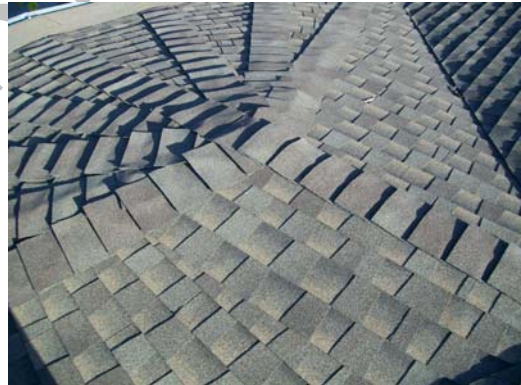
The fiberglass composition shingle roof appears to be in serviceable condition. A fiberglass composition shingle roof, if properly maintained, should have an expected overall lifespan of 15 to 20 years. The age of the roof was not determined.

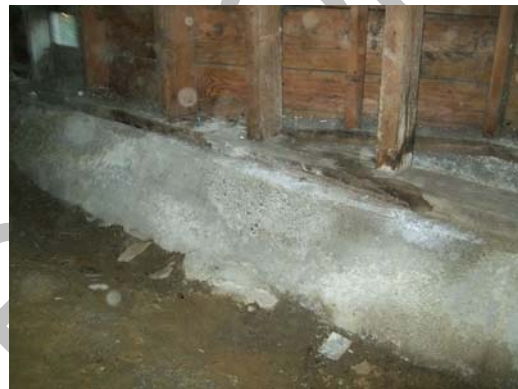
The perimeter foundation of the original home is a concrete battered (or angled) foundation. The depth or types of the footings is not known, nor a part of this report.

There is some spalling concrete in the sub area. Spalling is deterioration or flaking of concrete. The repair of spalling concrete is beyond the scope of this report. However, this spalling appears to be superficial.

There are some vertical cracks in the foundation walls. No rotation or shifting was noted, however. The repair of cracked foundation walls is beyond the scope of this report.

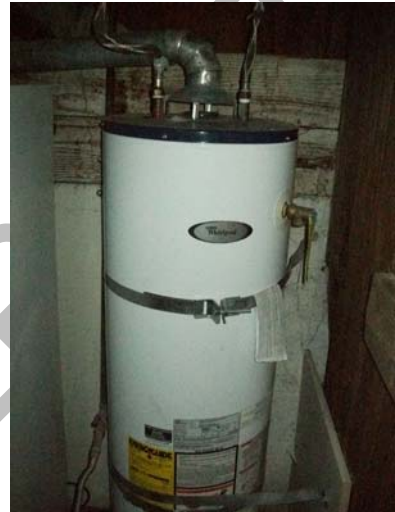
The natural gas hot water heater is located in the garage. The pressure relief valve is not plumbed. The flue is improperly installed. The slope of the flue is improper. The flue should have a minimum slope of $\frac{1}{4}$ " per foot to discharge. This flue is sloped downward. The hot water heater is seismically strapped. Water heaters generally have a 10-15 year life. The water heater is a 40 gallon unit that is 12 years old.

There is a masonry flue for the water heater and the furnace. While this was common building practice at the time when the home was built, it is presently not recommended, due to the possible cracking of the bricks and mortar, leading to carbon monoxide poisoning in the habitable rooms of the home. It is recommended that masonry flues be replaced with a UBC approved metal vent pipe.

1. Repair the flue as noted. A shorter water heater (or tankless water heater) should be used to provide the proper slope to discharge. Additionally, the metal flue should be used to duct both the water heater and furnace through the roof.
2. Plumb the pressure relief valve discharge pipe to within 6" of the concrete slab, or to the exterior of the building.

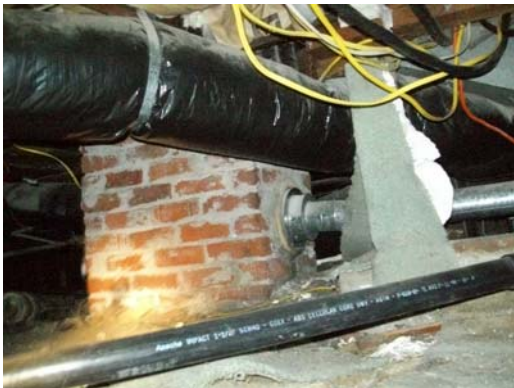
There is a masonry flue for the water heater and the furnace. While this was common building practice at the time when the home was built, it is presently not recommended, due to the possible cracking of the bricks and mortar, leading to carbon monoxide poisoning in the habitable rooms of the home. It is recommended that masonry flues be replaced with a UBC approved metal vent pipe.

It is noted that there is a broken duct in the sub area that hot air is escaping.

1. Encapsulate or remove the torn insulation on the heat duct pipes.
2. Repair the broken duct.

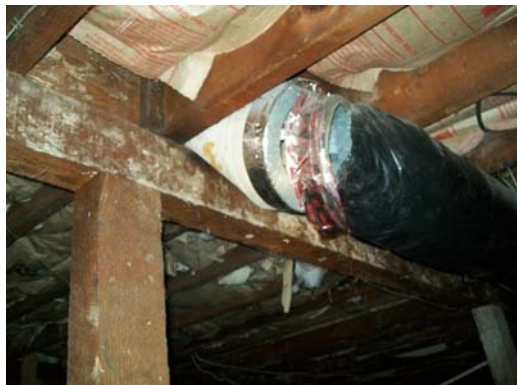
There may be asbestos on the heat duct boots. For further information about asbestos, contact a hazardous waste specialist. Asbestos in the torn or deteriorated condition is considered harmful. For further information about asbestos, contact a hazardous waste specialist.

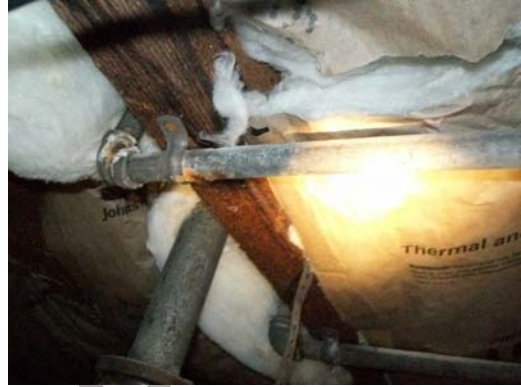
Galvanized steel water lines have a limited lifespan. The galvanized water lines under the original bathroom are in corroded condition. There is substantial rust on the joints of the pipes.

The water pressure is 90 psi (pounds per square inch). It is recommended a water regulator be installed below the main shut off to reduce the water pressure to the home to no more than 75 psi. Adequate water pressure should measure between 50 psi and 75 psi.

1. Removal of the galvanized water pipe is recommended.

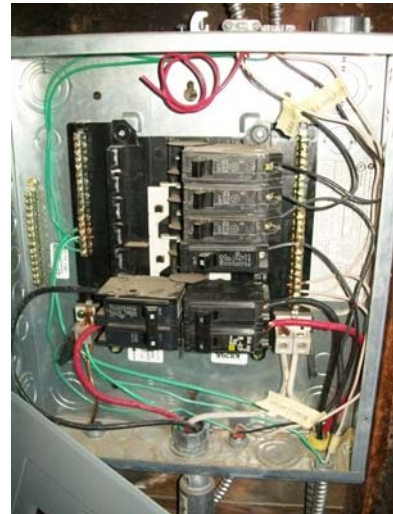
The electrical system is supplied from a 100 AMP, 110/220 volt, circuit breaker combination main service panel located on the front right corner of the home. Wiring in the main panel appears to be normal. The standard house wiring is copper.

There are two circuit breaker sub panels: located in the garage and back hall. It is noted that the sub panels were not labeled. It is recommended that the panels be labeled to make a determination of where the circuits are connected. However, whenever repairing or working on the wiring, it is recommended that the main circuit breaker be shut off as an additional precaution against shock.

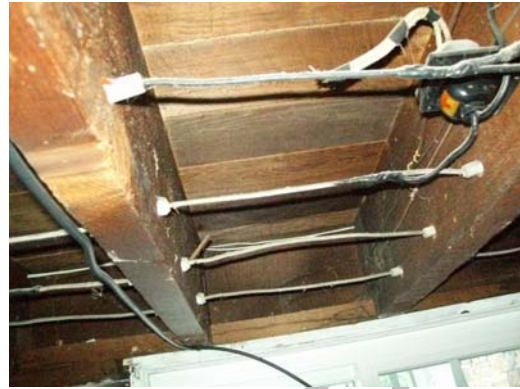
There is porcelain knob and porcelain tube wiring in the older section of the home. This is an ungrounded two wire, wiring system. This is considered an antiquated type of wiring that should be replaced with current NEC approved wiring. Have a licensed electrician inspect the wiring and make recommendations concerning replacement or repair.
