Property Inspection Sample Report

Property Address
000 Someplace Drive
Your Town, CA

Inspector
Michael Fogli, RREI, CREI
CA Contractor License 319523

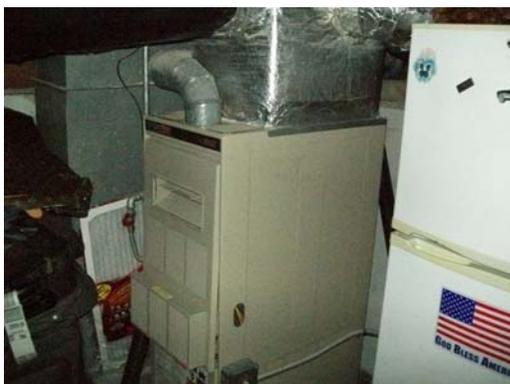
Heating

The heating system is not checked for uniformity or adequacy of heat supply to the various rooms, but only for operation. The home is heated by a natural gas furnace located in the basement. The unit was operable at the time of the inspection. The flue is improperly installed through the masonry chase. (See Water Heater Section)
