Property Inspection Sample Report

Property Address
000 Someplace Drive
Your Town, CA

Inspector
Michael Fogli, RREI, CREI
CA Contractor License 319523

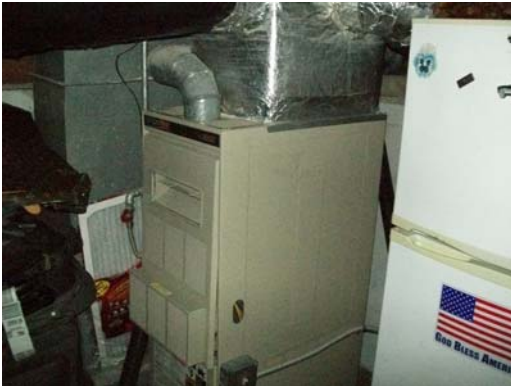
The heating system is not checked for uniformity or adequacy of heat supply to the various rooms, but only for operation. The home is heated by a natural gas furnace located in the basement. The unit was operable at the time of the inspection. The flue is improperly installed through the masonry chase. (See Water Heater Section)
